# Revisiting History

*In this Readers' Platform, your author reflects on a lift modernization undertaken 30 years ago.*

*by Colin Craney*

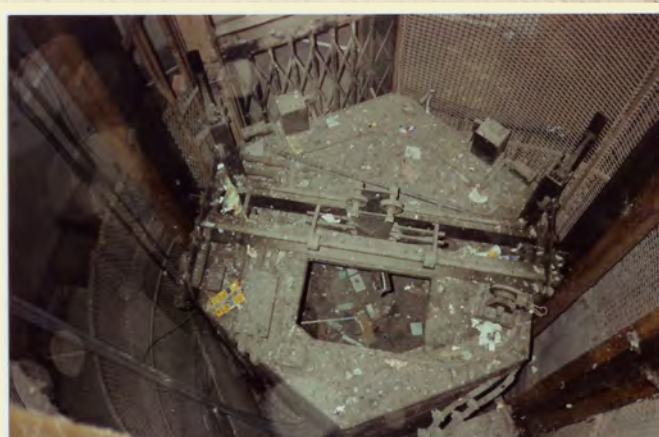
The lift had a 1350-lb (600 kg), nine-person capacity and originally served five landings traveling a distance of 17.5 m at 0.7 m/s. A geared machine with a DC drive motor was located in a motor room directly below the lift pit (Image 3). The lift shaft was circular with a six-sided lift car (Image 4). Whilst the machine is roped for four-rope traction, only two ropes of 13-mm diameter were actually provided. These were looped back at the lift car top rope termination with both ends terminated at the counterweight, providing for four-rope traction at the sheave grooves (Image 5). Two overhead diverters were located at the top of the lift shaft, diverting the ropes from the car and counterweight to the lift machine (Image 6).

Six-sided car in circular shaft

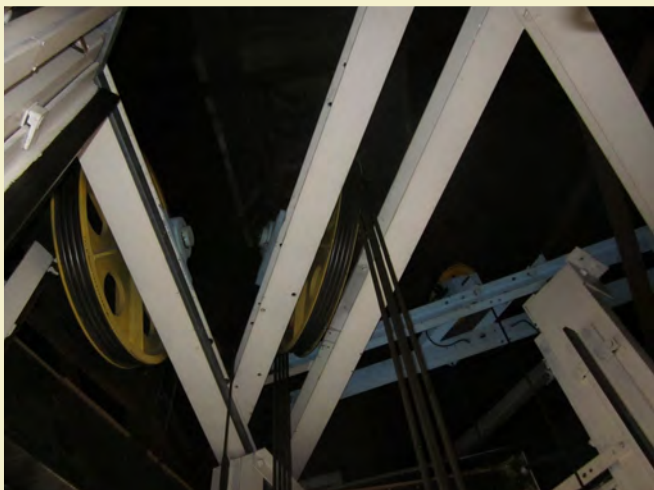
Restored overhead pulleys and new car overspeed governor

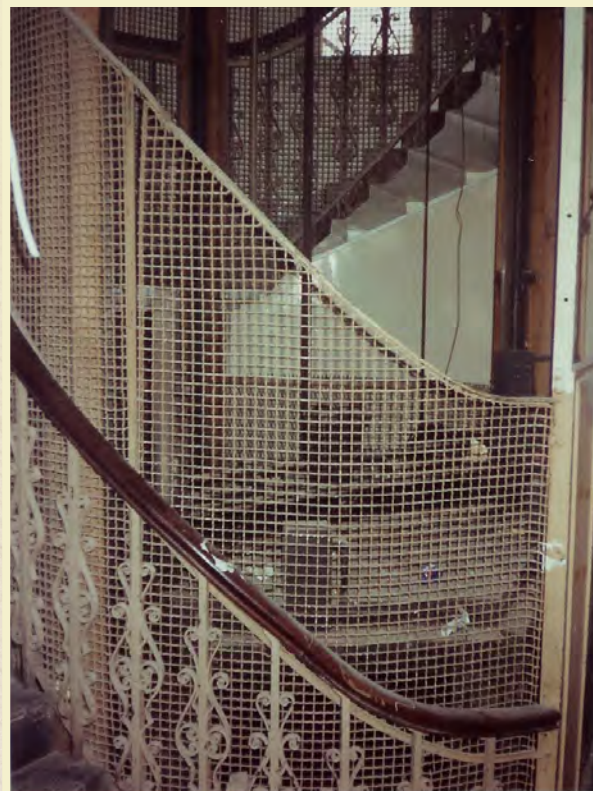
The shaft was open, with a 2-m-high steel mesh screen at the landings and in the interior of the circular stairwell (Image 7). The building was to be office accommodations, and the lift was to provide passenger service to a board room, with no public access. This assisted in relation to the retention of the collapsible lift car and landing gates, although it was necessary to replace the original gates which incorporated excessive gaps. New mid-bar design collapsible gates of similar design and construction, but with reduced gaps, were installed (Image 8).

Original shaft enclosure

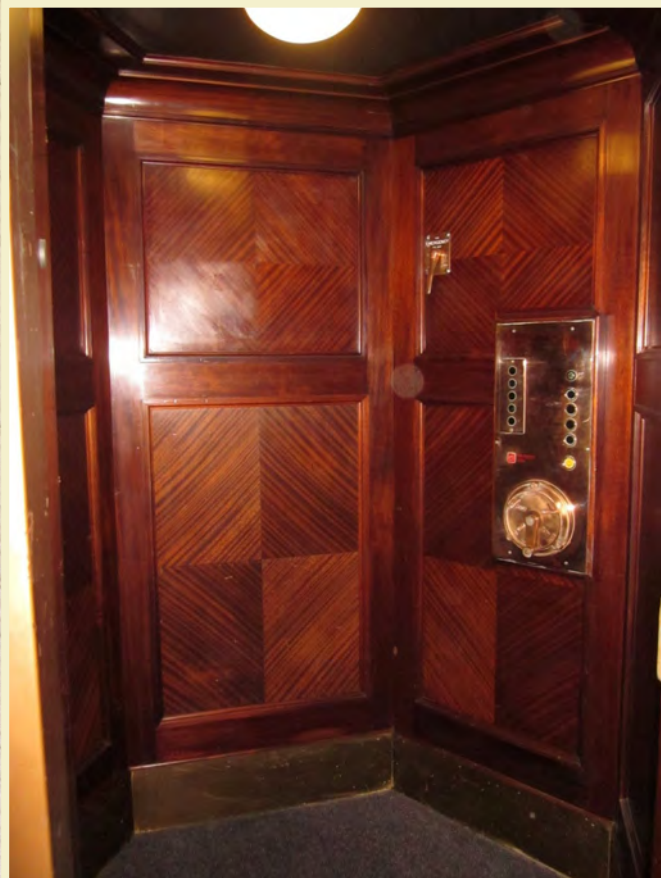
Restored lift car with retained lever emergency stop and attendant control

The architect required the attendant control handle and lever emergency stop handle be retained, albeit nonfunctional (Image 11). Originally, operation of the emergency stop handle whilst the lift was in motion locked a small-diameter wire rope which was connected to a mechanical trip of the main power supply isolator to open the lift drive circuits. Whilst the handle and attendant control features were retained for aesthetic purposes, modern automatic control and emergency stop switches were added.

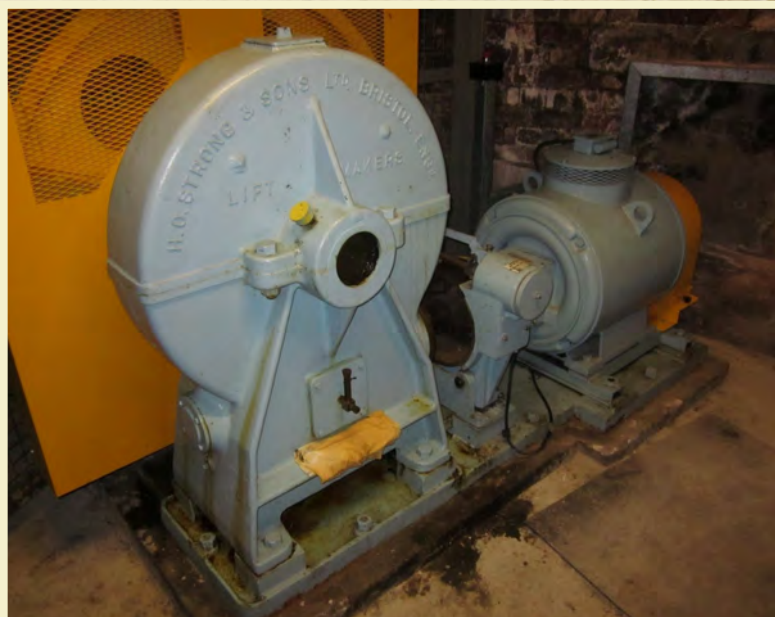
Restored lift machine still in good condition 30-plus years after restoration

Current condition is good. There is a minor oil leak from the machine gearbox, but otherwise, it is fine. The controller is dated, but also fine. We might now consider an infra-red screen across the car entrance to detect the intrusion of foreign objects and mitigate entrapment risk. We might also consider:

The lift machine was overhauled with a new AC drive motor and what was, at the time, a modern Dewhurst brake (Image 9). A microprocessor

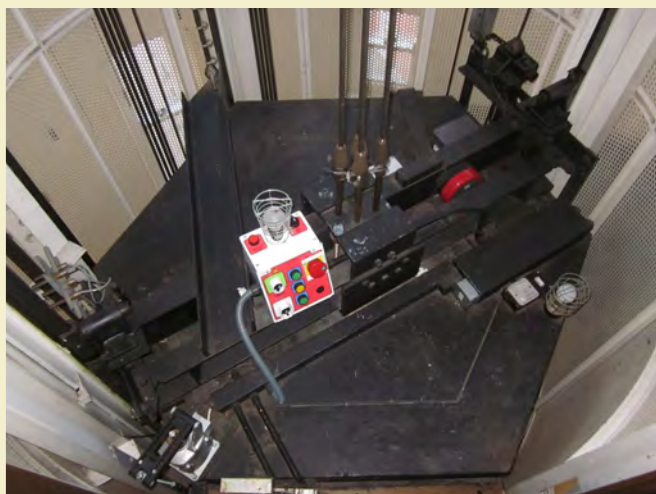
Refurbished lift car for single car entrance and new rope termination

The car had two entrances located side by side in two of its six sides. One of these became redundant, as access to a mezzanine floor was no longer required and the car enclosure was modified (Image 12). A car refurbishment contractor was engaged to remove the redundant car entrance and reinstate the sidewall. An additional emergency-stop switch was installed, as the redundant car entrance had been directly adjacent to the car operating panel that incorporated the original emergency stop switch. (The British Standard relating to the use of collapsible car gates required an emergency stop switch be positioned within easy reach of the car gate). The architect would not consider lift shaft fascias, so a solenoid released car gate interlock prevented opening of the car gate between floors.

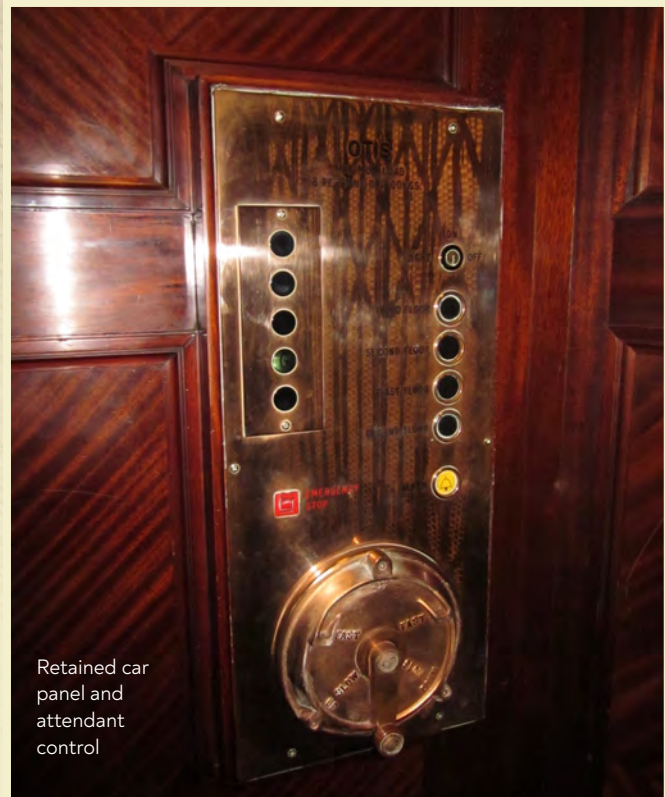
Retained car panel and attendant control

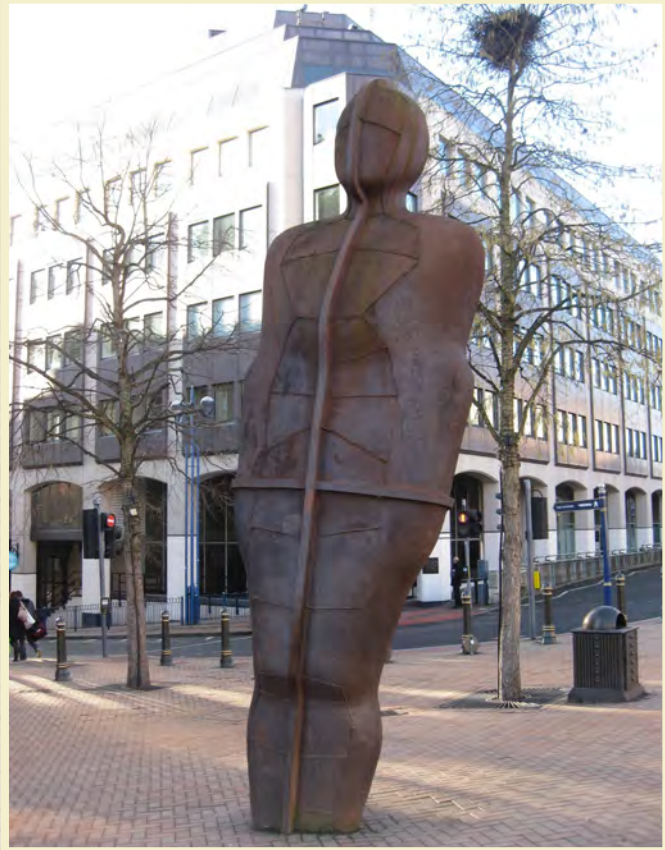
"Iron:Man" by Sir Antony Gormley (in original position prior to temporary removal)

In the original paper, I also wrote about Sir Antony Gormley's "Iron:Man" statue, which was, at the time, installed directly in front of the building (Image 13), but which has since been removed (temporarily, we hope) to make space for a tram line extension. "Iron:Man" was commissioned as a gift to the city by the original occupier of the development and is said to represent the city's industrial heritage. Its installation and subsequent removal was something of a work in itself as "Iron:Man" is 6 m high and weighs 6000 kg, and, when installed, leans 7.5 degrees backwards and 5 degrees to its left, with its feet buried below the pavement.
